RFB PROPERTY INSPECTIONS

March 23, 2007

Inspection address: 123 Main St. Newport Beach, CA 92626

REPORT SUMMARY

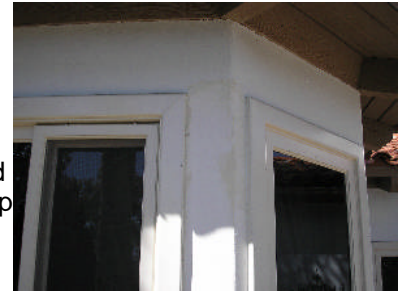
Cracks noted are typical. Monitor for future movement and repairs as needed. Weep screed was not visible in certain areas, this is the bottom metal which helps release moisture from a stucco wall. Ideally, there should be a 2 inch clearance from concrete or hardscape and a 4 inch clearance from soil. Covering the weep or not having one may prevent proper wall drainage which causes moisture damage and may allow a path for wood destroying insects/organisms. At this time there is no visible related problems. If you experience moisture stains/damage on walls inside by base moldings then a correction by adding a weep screed at the required height would be recommended. See termite report. Stains/patches noted, ask seller about this.

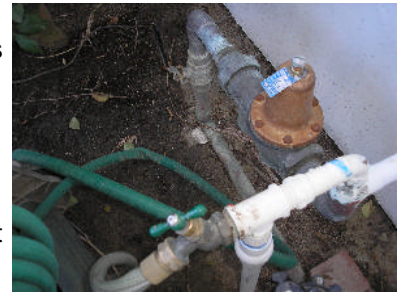
Main shut-off is located in the front. Valves are never tested, leaks always develop if valve has not been maintained. If this is a concern then we suggest the seller demonstrate operation and if there are leaks then repairs are recommended. PSI pressure is 70, water pressure is satisfactory. Monitor this condition. If pressure exceeds 80 PSI then an adjustment to the regulator would be recommended. If there is no regulator then one would be recommended to be installed. Regulator installed, rust noted. Main line appears to be 1 inch. This is usually adequate for most home needs. Main valve has some corrosion. Valves should be turned regularly and lubricated to resist corrosion. This valve appears to be neglected. No active leakage noted at this time.

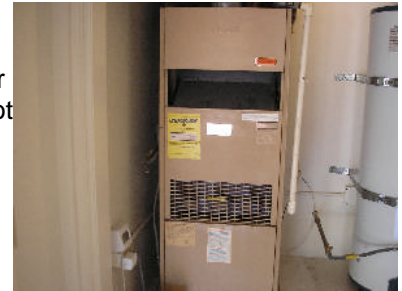
5. Furnace appears to be original at exterior closet by master. It was operational. Average life of a gas fired forced air furnace is 20 years. Life does extend further than this in Southern California because it is not used as often as back East. The age label was not readable. Ask the seller if they would know when it was installed. The manufacturer recommends annual servicing. Ask the seller for service records. If the unit has not been serviced in the past year we recommend servicing by a licensed heating contractor before the close of escrow and at that time the heat exchanger condition should be verified. Heat exchangers are beyond the scope of this inspection. A cracked heat exchanger is a fatal flaw which cannot be confirmed unless the furnace is disassembled. This is a possible SAFETY HAZARD.

PRIMARY UNIT: Furnace appears to be original. It was operational. Average life of a gas fired forced air furnace is 20 years. Life does extend further than this in Southern California because it is not used as often as back East. The age label was not readable. Ask the seller if they would know when it was installed. Probably 20 years ago. The manufacturer recommends annual servicing. Ask the seller for service records. If the unit has not been serviced in the past year we recommend servicing by a licensed heating contractor before the close of escrow and at that time the heat exchanger condition should be verified. Heat exchangers are beyond the scope of this inspection. A cracked heat exchanger is a fatal flaw which cannot be confirmed unless the furnace is disassembled. This is a possible SAFETY HAZARD.

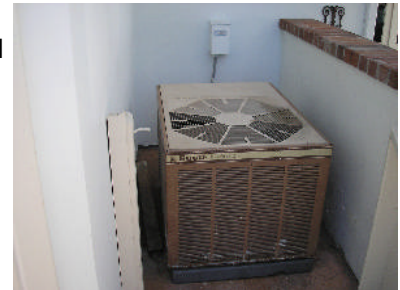
7. Operational. Bedroom unit is 6 years old, average life is 15. A/C units should be serviced annually according to manufacturer. Ask the seller if they have service records. If there has not been servicing in the past year we recommend servicing before the close of escrow.

SYSTEM CONDITION: Operational. Bedroom unit is 6 years old, average life is 15. A/C units should be serviced annually according to manufacturer. Ask the seller if they have service records. If there has not been servicing in the past year we recommend servicing before the close of escrow.

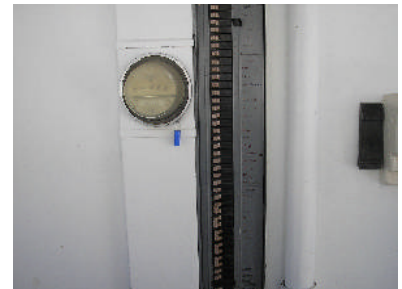
Exterior of house. Amperage at main panel is 200. Clasp to lock panel is broken.

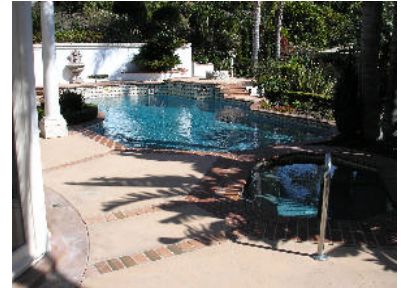
28. Minor stains noted. Pool plaster average life is 15 years. Ask seller the age of the surface. Listing agent said it may be only 1 year old.

TYPE: Concrete/Plaster.
CONDITION: Appears Serviceable. Minor stains noted. Pool plaster average life is 15 years. Ask seller the age of the surface. Listing agent said it may be only 1 year old.
